# SAN ONOFRE'S STEAM GENERATOR FAILURES COULD HAVE BEEN PREVENTED

May 14, 2012

REPORT COMMISSIONED BY FRIENDS OF THE EARTH

ARNIE GUNDERSEN, MSNE  
FAREWINDS ASSOCIATES  
BURLINGTON, VERMONT, USA

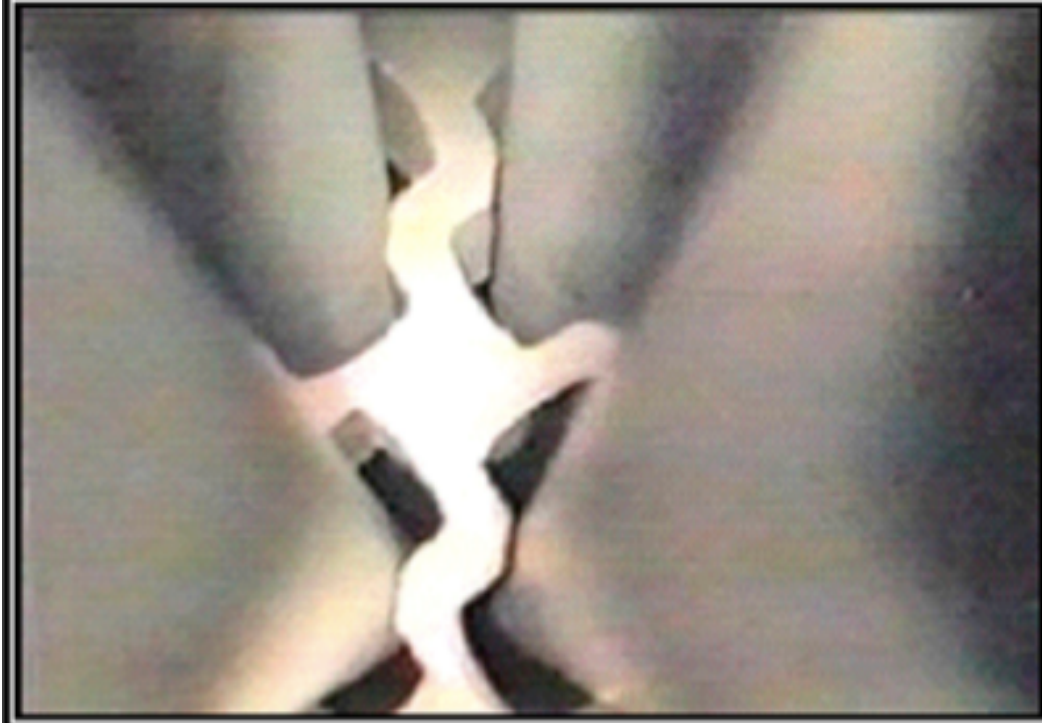
**Figure 1: Broached Tube Support Plate - Designed To Keep Tubes From Rattling**

**Broached (quatrefoil and trefoil) tube support plates (TSPs)<sup>8</sup>**

The flow resistance of the Mitsubishi broached plate is *much higher* than that of the original Combustion Engineering egg crate design because the tubes are so tightly packed in the original CE San Onofre steam generators. By reviewing the documents thus far produced, it appears that due to Mitsubishi's fabrication experience with broached plates, both Edison and Mitsubishi missed this key difference in the design and fabrication of the new San Onofre steam generators.

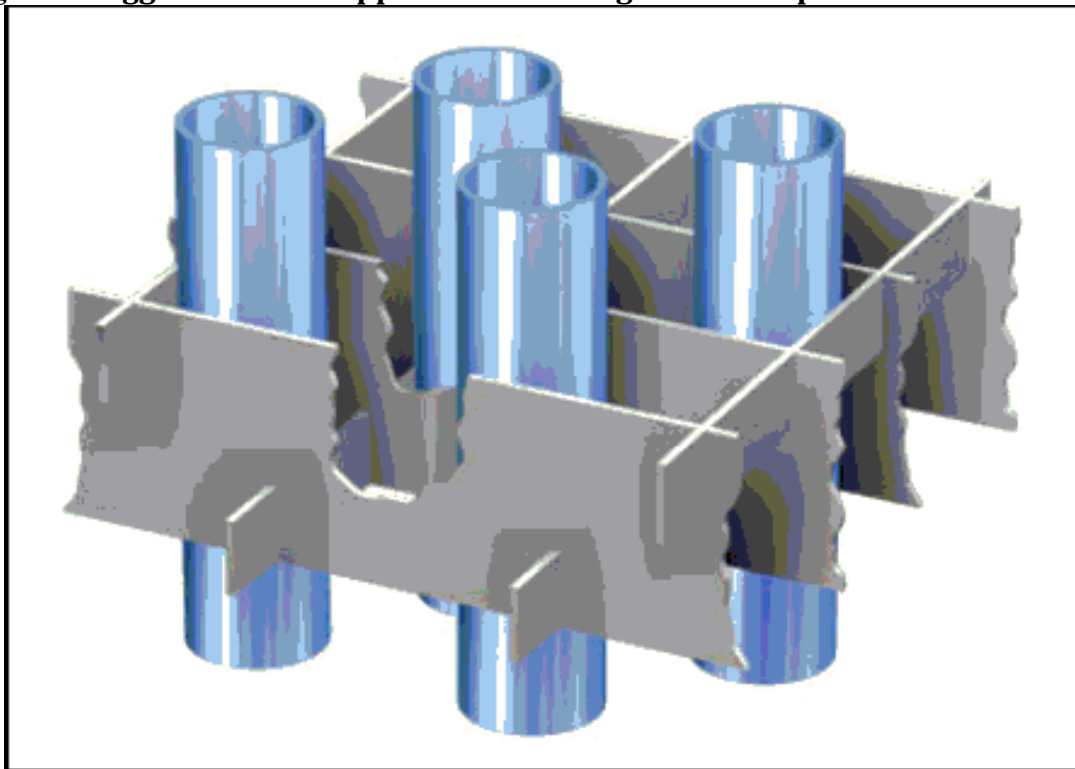
**Figure 2: Eggcrate Tube Support Plate - Designed To Keep Tubes From Rattling**

**Horizontal Tube Supports (Eggcrate)<sup>9</sup>**

The original steam generators designed and manufactured by CE for San Onofre were successfully operated 28 years. Moreover the original steam generators had a triangular tube pitch pattern, very closely packed U-tubes, and unique egg-crate tube supports that kept the tubes from vibrating and colliding. The pitch to diameter ratio of tubes in the original CE generators is dramatically different from any of the Westinghouse generators fabricated by Mitsubishi. Moreover, an NRC licensing review would have identified the fact that the Mitsubishi computer design code, which is based upon Westinghouse models, was not appropriate for design changes to the San Onofre replacement steam generators originally designed by CE.
